Technical Bulletin

Model(s)	Year	Eng. Code	Trans. Code	VIN Range From	VIN Range To
Tiguan	2012-2013	2.0T (CCTA)	All	All	All

20 12 04 December 5, 2012 2031557

Crank, No Start after Long Periods without Driving

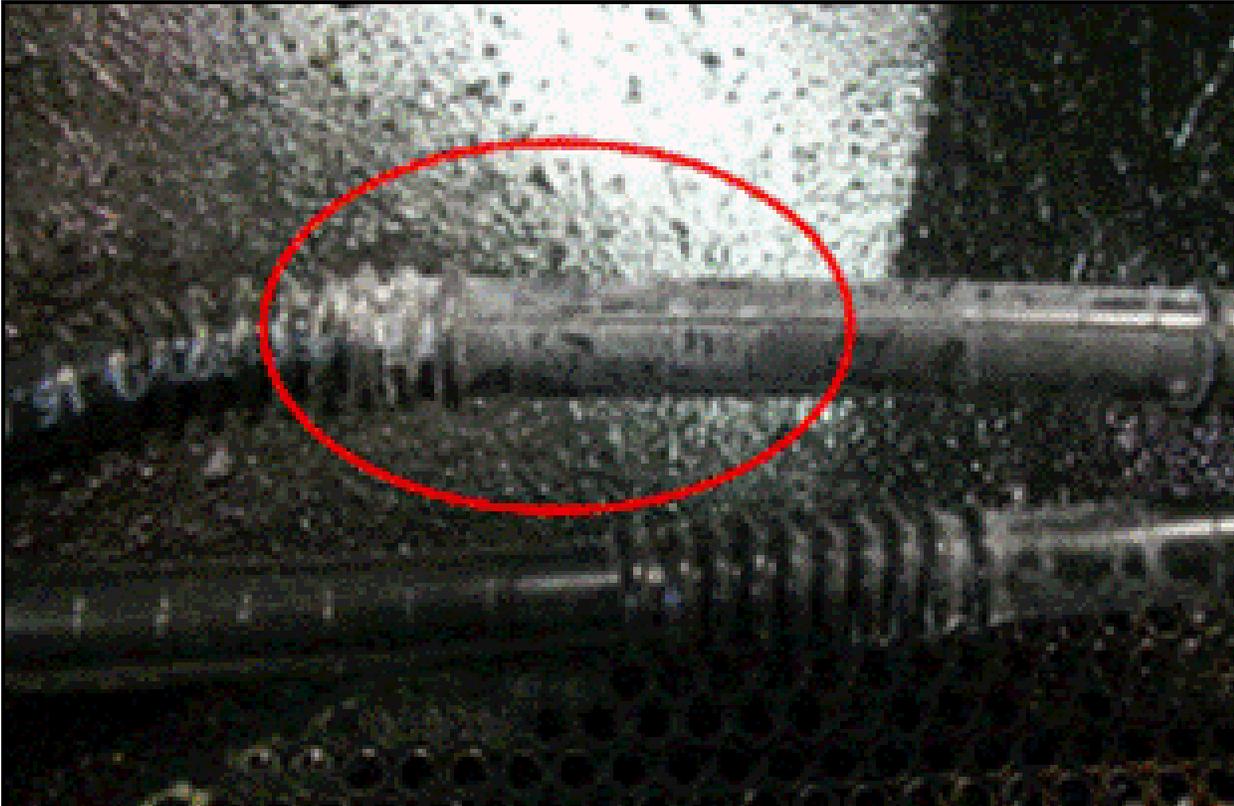
Figure 1

The black in-tank fuel lines contain a material known as PA12. PA12 was not meant to be used with fuel containing alcohol/methanol/ethanol. If PA12 fuel lines sit in fuel for over 3 day without driving and in temperatures over 77° F (25° C) a chemical reaction occurs that creates small white crystals to form on the lines (figure 1). These crystals can flake off into the fuel, gumming up the pumps and lines.

A reaction of the in-tank fuel line exterior will only occur one time, once the material has been removed, the lines and system require no further repairs.

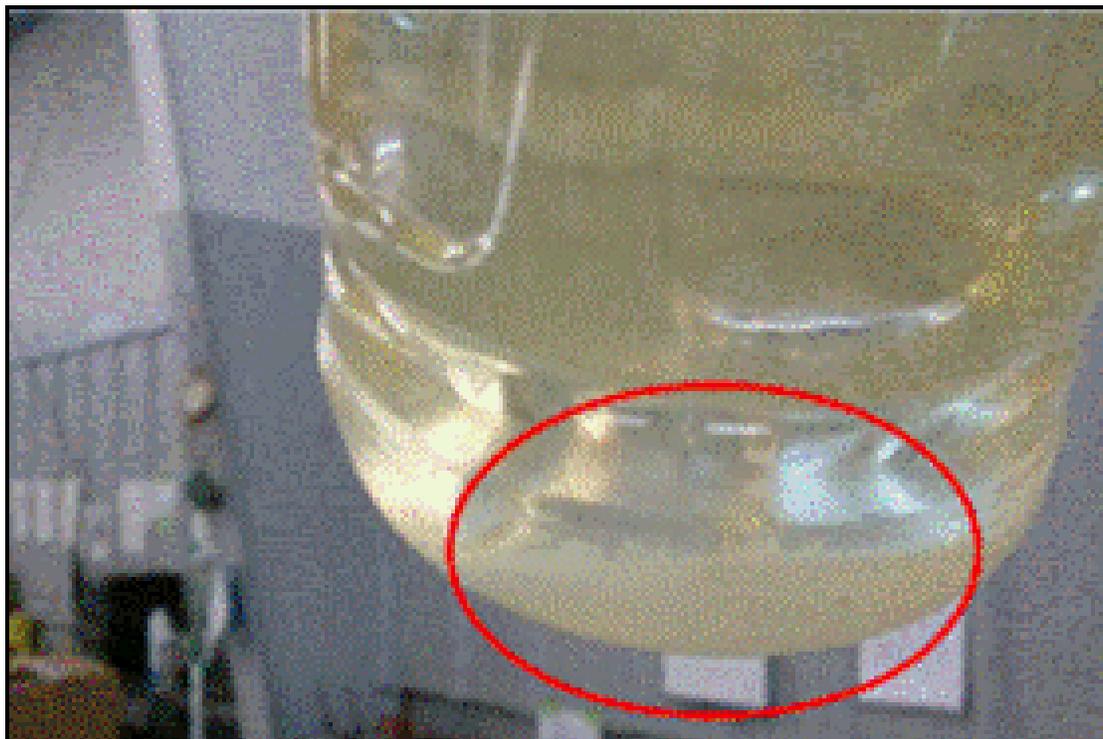
Figure 4

- Check the sample of fuel for debris.

- If debris is found (figure 4), remove the rear seat bottom to gain access to the in-tank fuel pump.
- If no debris is found (figure 4), please contact the Volkswagen Technician Helpline for further instructions.

- Remove the in-tank fuel pump and recover as much of the contaminated fuel as possible using an approved gas caddy.
- Once the fuel tank is empty, reinstall the in-tank fuel pump, rear seat bottom and fill the tank with \$20.00 of new fuel.

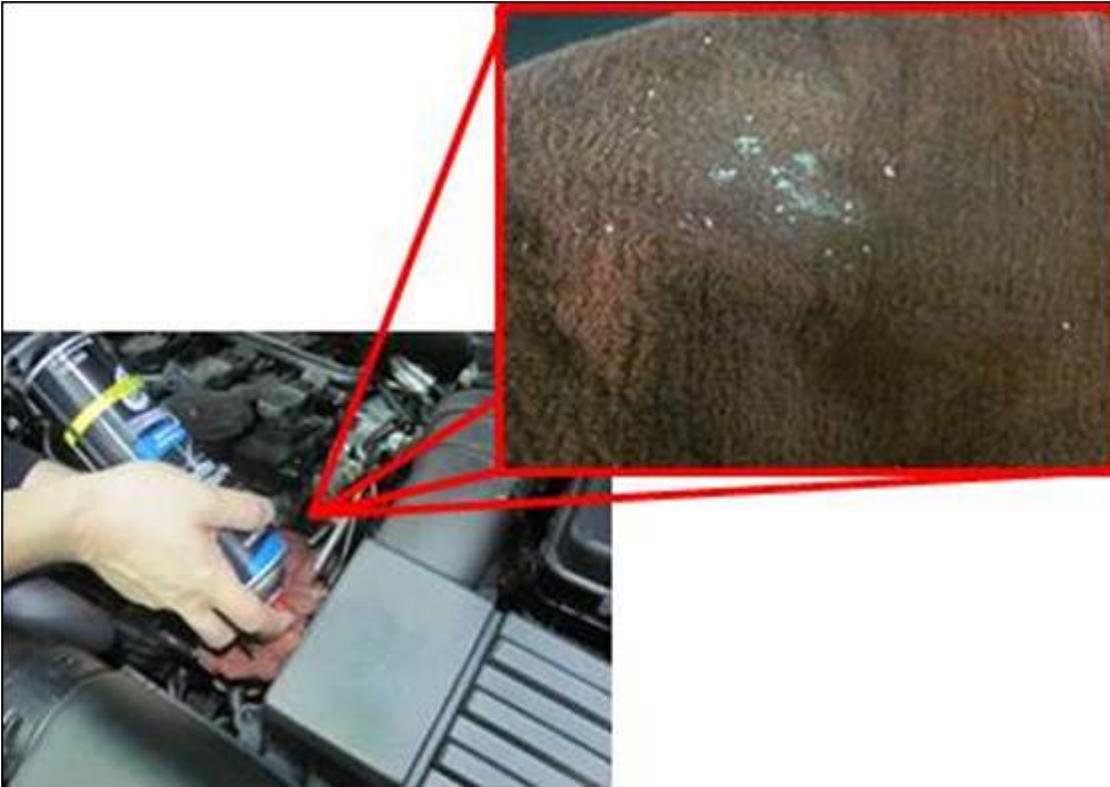
Figure 6 shows the placement of the brake cleaner nozzle to the high pressure pump. Figure 7 shows the placement of the shop rag and the removed debris, some pumps may contain more/less debris.

Make sure the shop rag is wrapped around the inlet/spray nozzle before spraying the brake cleaner
